PACSystems RX3i

IC695CPE305-ABAJ

Central Processing Unit

GFK-2714J

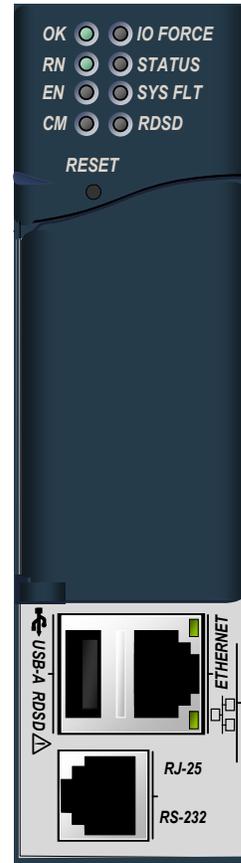
The PACSystems[†] RX3i CPE305 can be used to perform real time control of machines, processes, and material handling systems. The CPU communicates with the programmer via the internal Ethernet port or a serial port. It communicates with I/O and Intelligent Option modules over a dual PCI/Serial backplane.
